**Flood Control Project Maintenance
Levee Inspections****LMA District Cover Sheet****Spring 2011 Levee Inspection Results****Reclamation District No. 0544 Upper Roberts Island**

Levee Inspection Report By Mile - Spring 2011

Reclamation District No. 0544 Upper Roberts Island

Waterway						Bank	Unit Miles	Inspection Start/End	Inspector
Unit No. 01 San Joaquin River						Left	6.11	04/19/2011 04/19/2011	Richard Willoughby

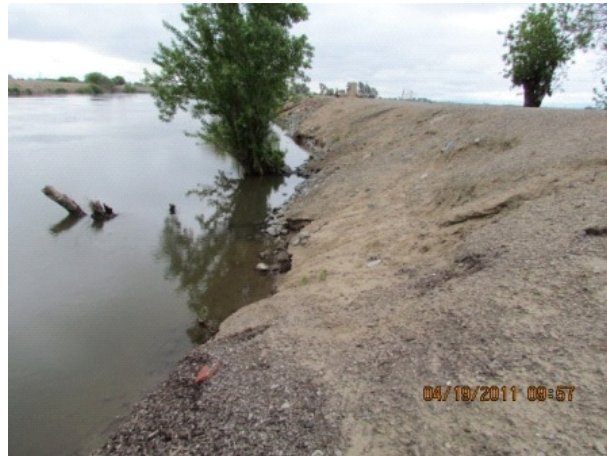
Levee Mile Report Line	3
Start Levee Mile	0.00
End Levee Mile	0.02
Location	Water Side
Category	Earthen Levee
Item	Erosion / Bank Caving

Looking south at erosion and slope stability issue.

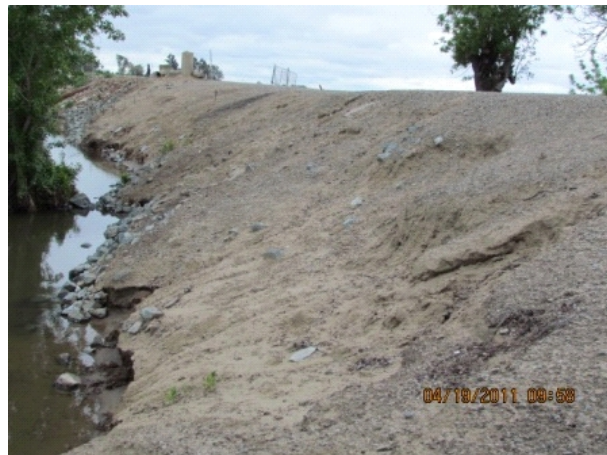
Levee Mile Report Line	3
Start Levee Mile	0.00
End Levee Mile	0.02
Location	Water Side
Category	Earthen Levee
Item	Erosion / Bank Caving

Looking south at waterside erosion and slope stability.

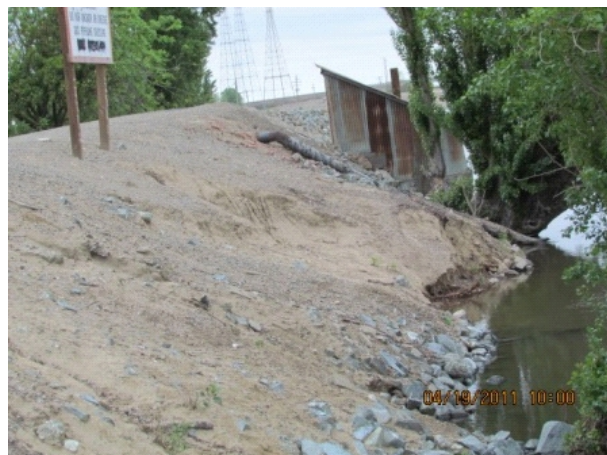
Levee Mile Report Line	3
Start Levee Mile	0.00
End Levee Mile	0.02
Location	Water Side
Category	Earthen Levee
Item	Erosion / Bank Caving

Looking north at waterside erosion and slope stability.

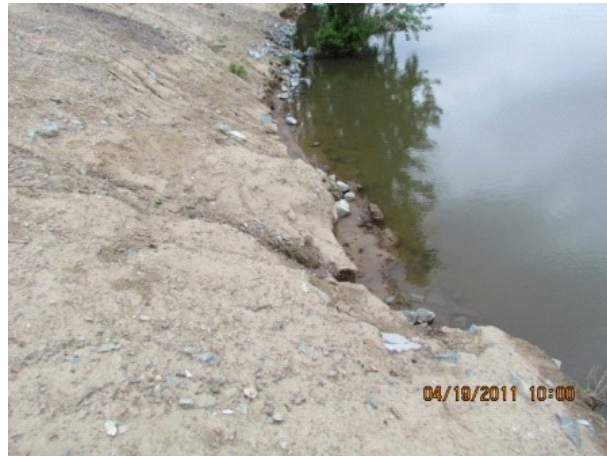
Levee Mile Report Line	3
Start Levee Mile	0.00
End Levee Mile	0.02
Location	Water Side
Category	Earthen Levee
Item	Erosion / Bank Caving

Looking north at erosion along waterside slope and toe.

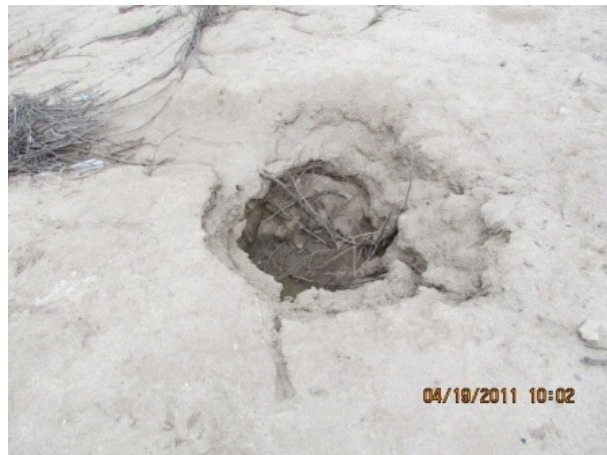
Levee Mile Report Line	4
Start Levee Mile	0.04
End Levee Mile	0.04
Location	Land Side
Category	Earthen Levee
Item	Slope Stability

Looking at sink hole (approx. 36" deep and 72" in diameter) on landside shoulder and slope.

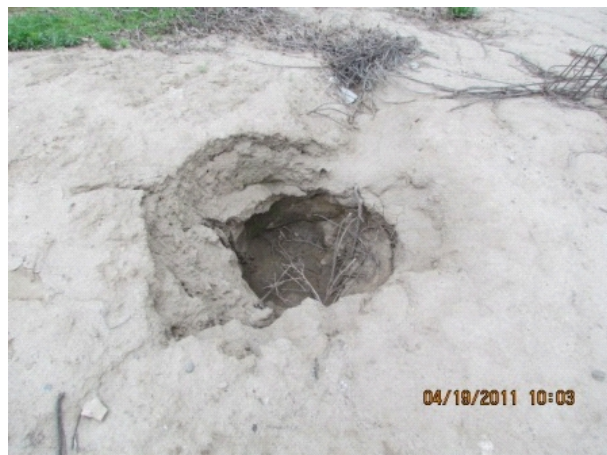
Levee Mile Report Line	4
Start Levee Mile	0.04
End Levee Mile	0.04
Location	Land Side
Category	Earthen Levee
Item	Slope Stability

Looking east at sink hole on landside shoulder.

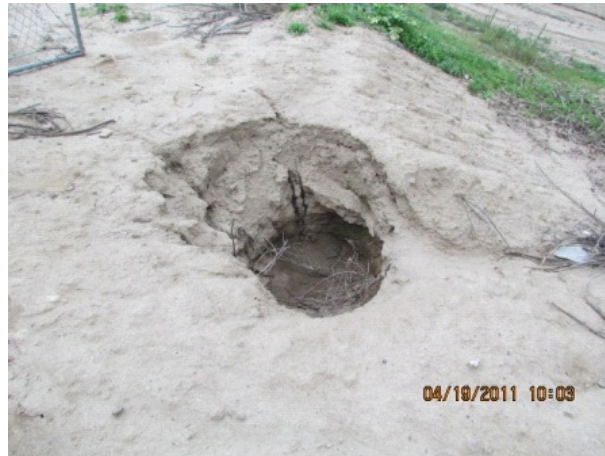
Levee Mile Report Line	4
Start Levee Mile	0.04
End Levee Mile	0.04
Location	Land Side
Category	Earthen Levee
Item	Slope Stability

Looking south at sink hole on landside shoulder.

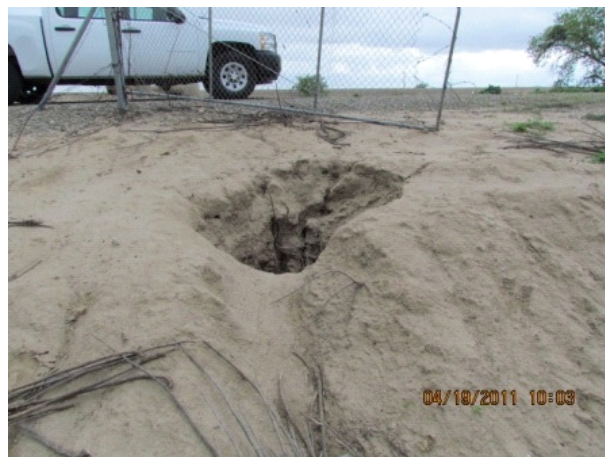
Levee Mile Report Line	4
Start Levee Mile	0.04
End Levee Mile	0.04
Location	Land Side
Category	Earthen Levee
Item	Slope Stability

Looking east at sink hole on landside shoulder.

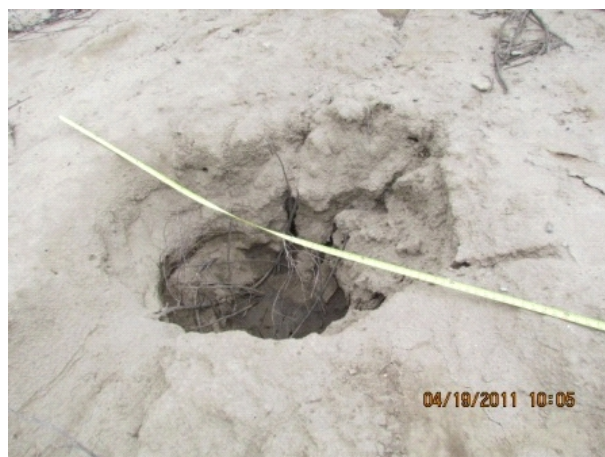
Levee Mile Report Line	4
Start Levee Mile	0.04
End Levee Mile	0.04
Location	Land Side
Category	Earthen Levee
Item	Slope Stability

Sink hole on measuring 36" deep by 72" in diameter.

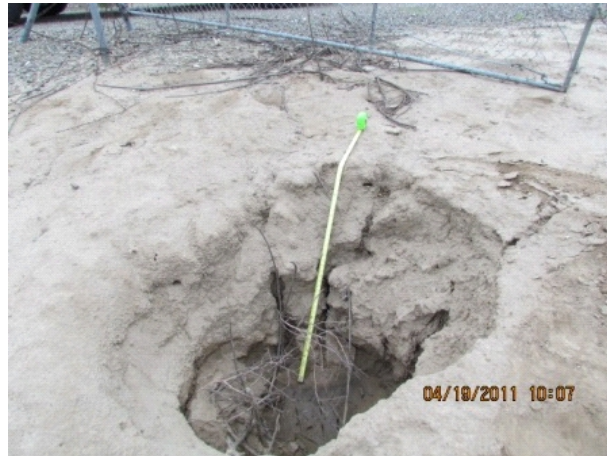
Levee Mile Report Line	4
Start Levee Mile	0.04
End Levee Mile	0.04
Location	Land Side
Category	Earthen Levee
Item	Slope Stability

Sink hole on landside shoulder approx. 36" deep.

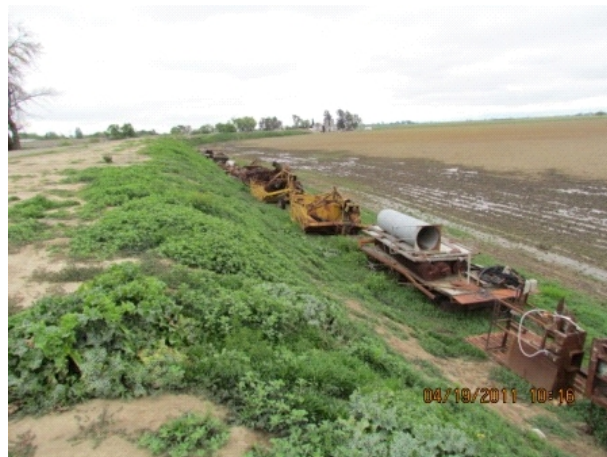
Levee Mile Report Line	5
Start Levee Mile	0.05
End Levee Mile	0.18
Location	Land Side
Category	Earthen Levee
Item	Encroachments

Looking south at equipment along landside toe.

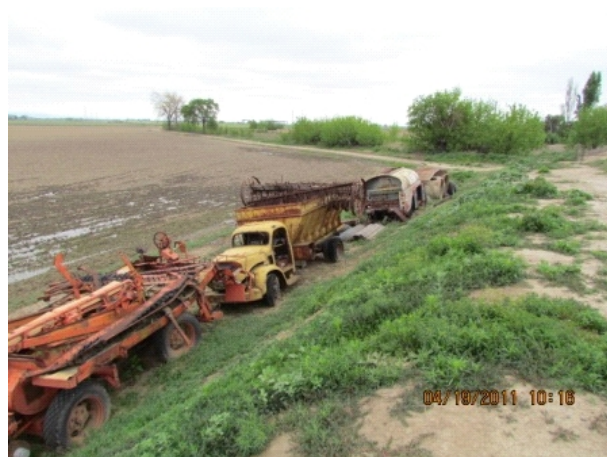
Levee Mile Report Line	5
Start Levee Mile	0.05
End Levee Mile	0.18
Location	Land Side
Category	Earthen Levee
Item	Encroachments

Looking north at equipment along landside toe.

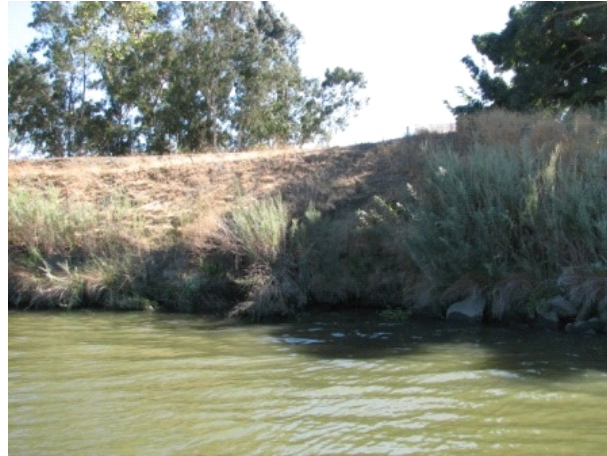
Levee Mile Report Line	6
Start Levee Mile	0.41
End Levee Mile	0.45
Location	Water Side
Category	Supplemental
Item	DWR Erosion Survey

Upstream view of site where a 4-foot vertical scarp has occurred.

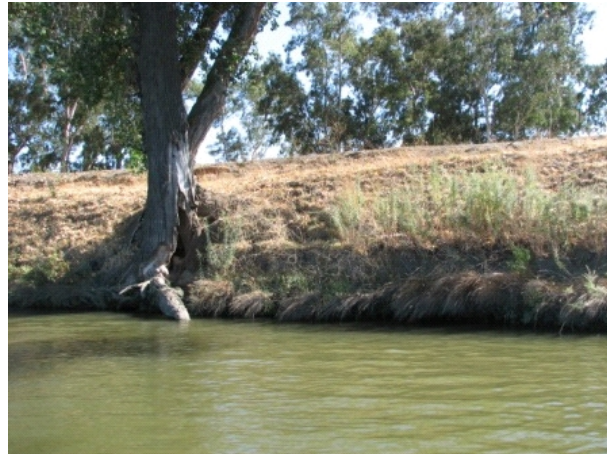
Levee Mile Report Line	6
Start Levee Mile	0.41
End Levee Mile	0.45
Location	Water Side
Category	Supplemental
Item	DWR Erosion Survey

Upstream view of site where undermining of the slope has occurred.

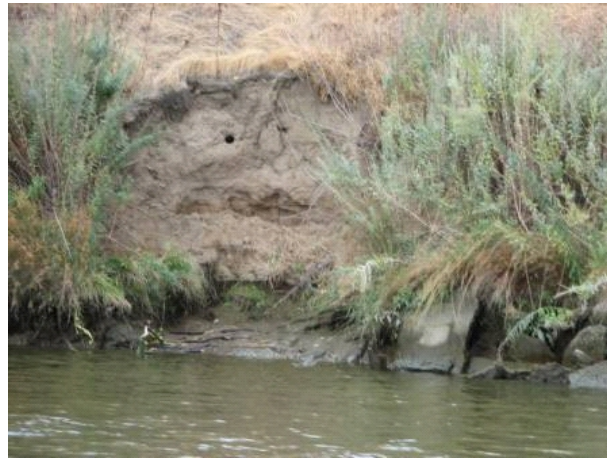
Levee Mile Report Line	6
Start Levee Mile	0.41
End Levee Mile	0.45
Location	Water Side
Category	Supplemental
Item	DWR Erosion Survey

Close-up view of a 4-foot long vertical scarp. This photo was taken on 09/30/2009.

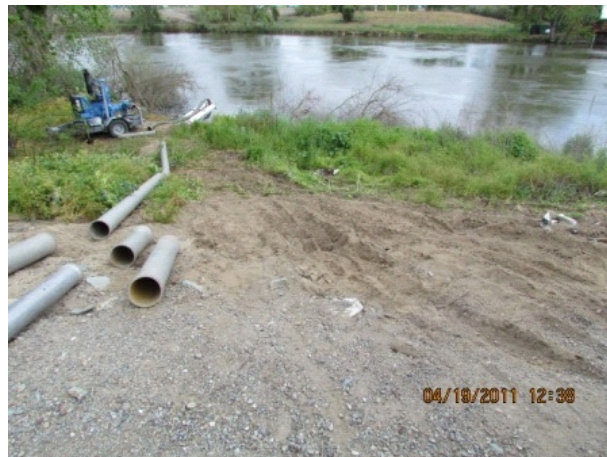
Levee Mile Report Line	29
Start Levee Mile	2.98
End Levee Mile	2.98
Location	Land Side
Category	Earthen Levee
Item	Encroachments

Looking east at landowner installing temporary pump system without permit and damage to waterside slope.

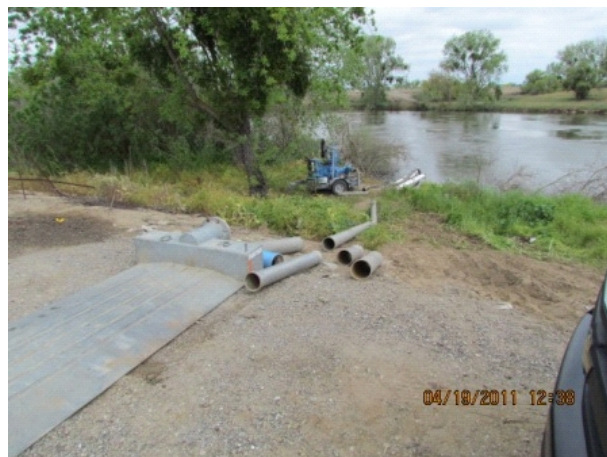
Levee Mile Report Line	29
Start Levee Mile	2.98
End Levee Mile	2.98
Location	Land Side
Category	Earthen Levee
Item	Encroachments

Looking east at pump and irrigation ramp on levee waterside and crown.

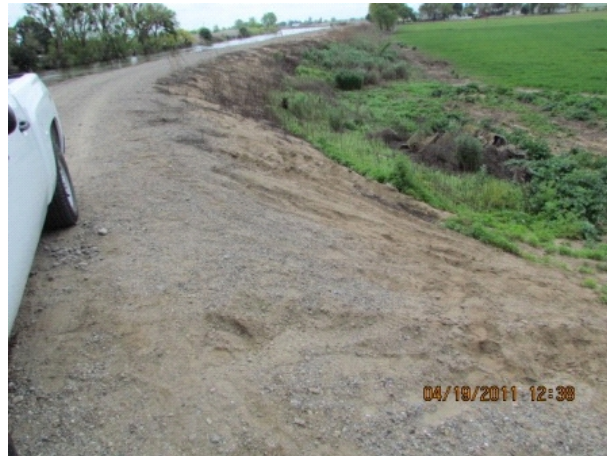
Levee Mile Report Line	29
Start Levee Mile	2.98
End Levee Mile	2.98
Location	Land Side
Category	Earthen Levee
Item	Encroachments

Looking south at damage landside slope caused by vehicle traffic.

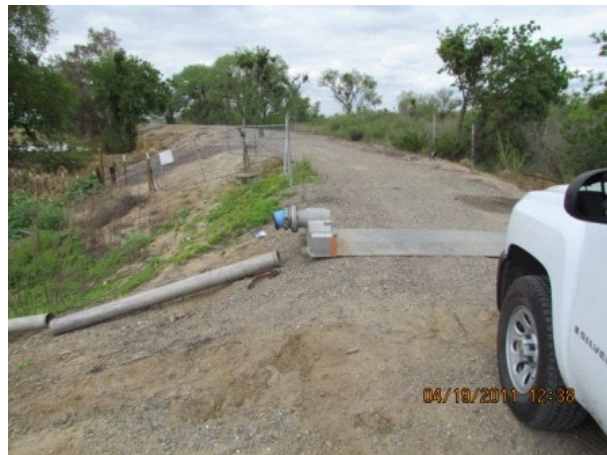
Levee Mile Report Line	29
Start Levee Mile	2.98
End Levee Mile	2.98
Location	Land Side
Category	Earthen Levee
Item	Encroachments

Looking north at pipe and pipe ramp on landside and crown of levee.

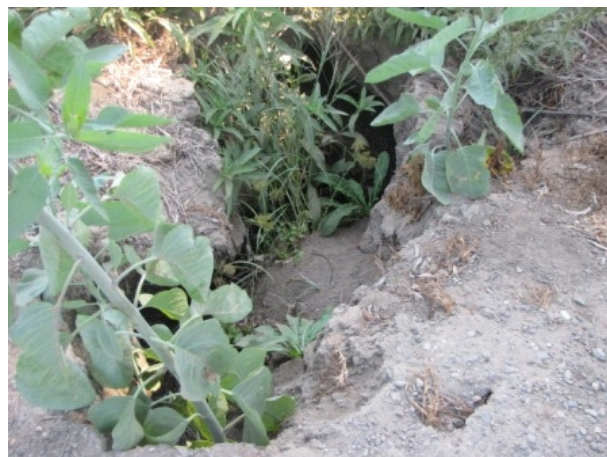
Levee Mile Report Line	40
Start Levee Mile	4.32
End Levee Mile	4.32
Location	Water Side
Category	Earthen Levee
Item	Slope Stability

Looking east at erosion on waterside slope and berm cause by leaking 10" pipe.

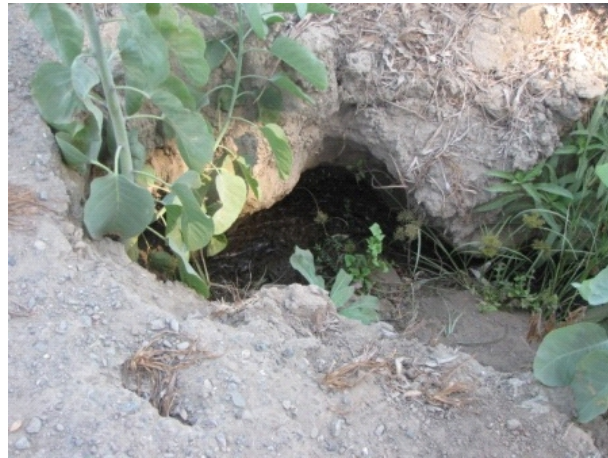
Looking west at hole on waterside shoulder and slope cause by possible broken pipe.

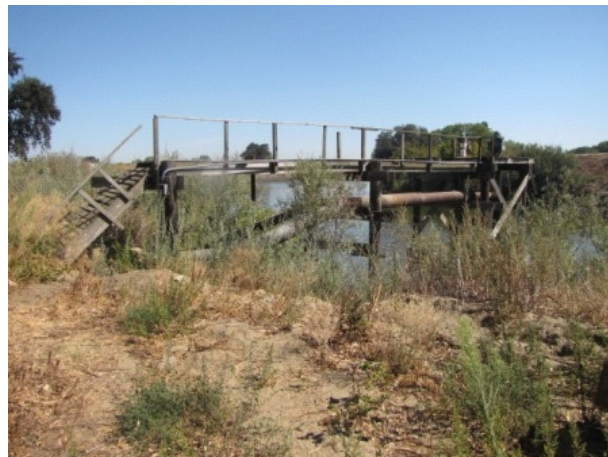
Levee Mile Report Line	40
Start Levee Mile	4.32
End Levee Mile	4.32
Location	Water Side
Category	Earthen Levee
Item	Slope Stability

Looking northwest at pump and platform for 10" possible leaking pipe.

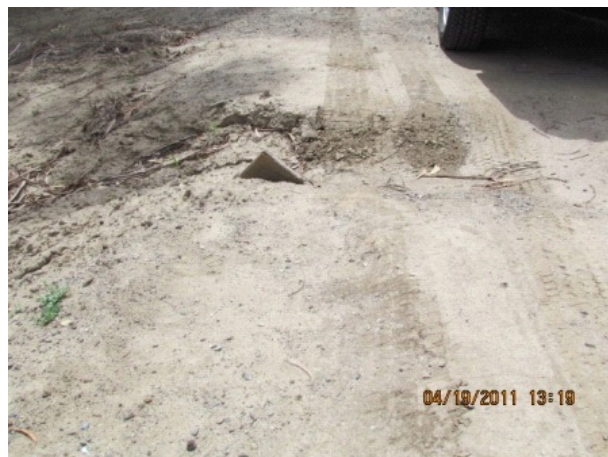
Levee Mile Report Line	42
Start Levee Mile	4.33
End Levee Mile	4.33
Location	Crown
Category	Earthen Levee
Item	Crown Surface / Depressions / Rutting

Looking south at depression greater than 6" on waterside shoulder.

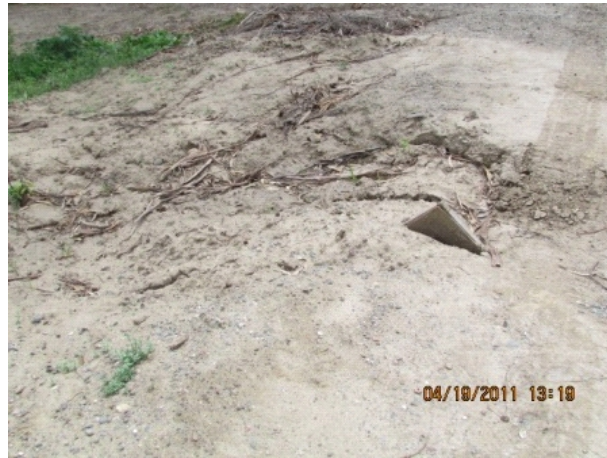
Looking southeast at depression on waterside shoulder.

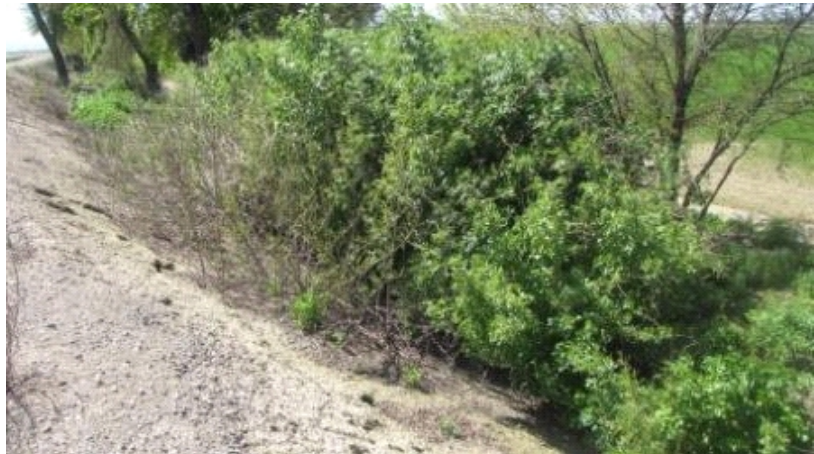
Levee Mile Report Line	45
Start Levee Mile	4.53
End Levee Mile	4.53
Location	Land Side
Category	Earthen Levee
Item	Vegetation

Looking south at elderberries on landside slope and toe.

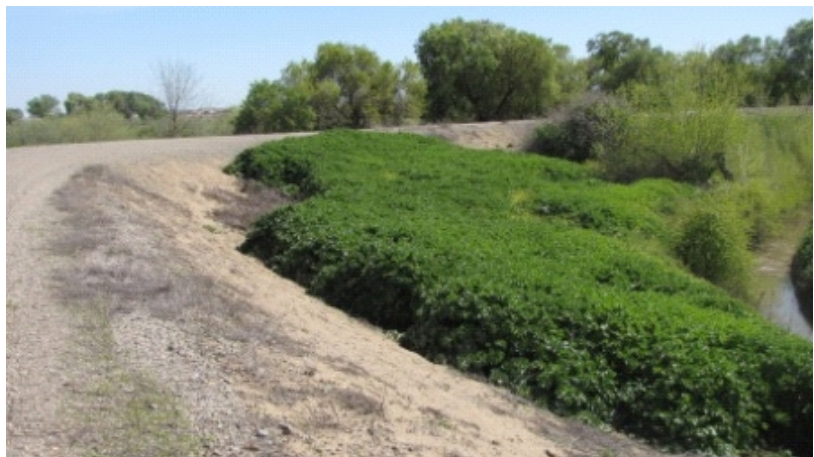
Levee Mile Report Line	53
Start Levee Mile	5.00
End Levee Mile	5.30
Location	Land Side
Category	Earthen Levee
Item	Vegetation

Looking southeast at dense veg. on landside slope and toe.

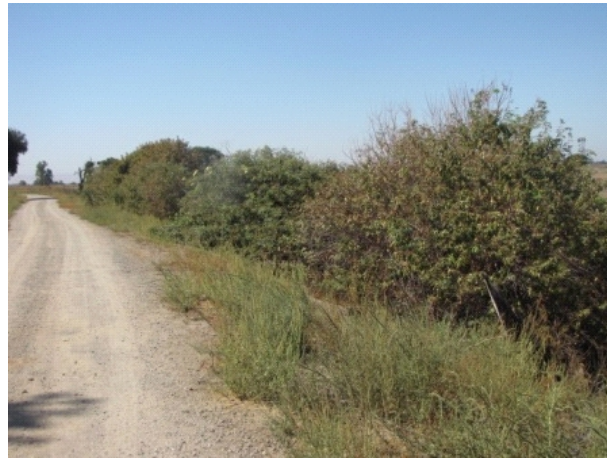
Looking southwest on elderberries on landside slope and toe.

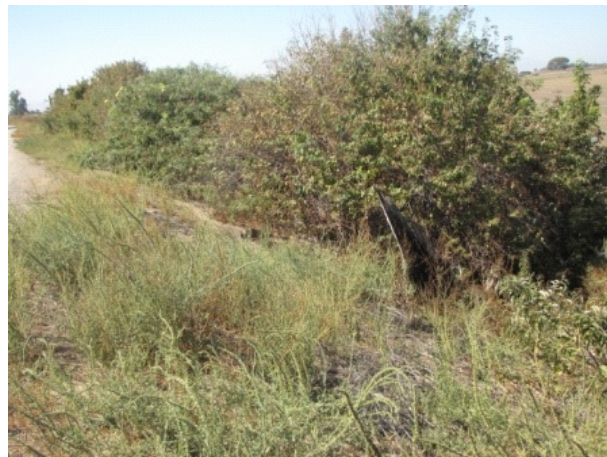
Levee Mile Report Line	57
Start Levee Mile	5.54
End Levee Mile	5.60
Location	Land Side
Category	Earthen Levee
Item	Vegetation

Looking south at elderberries on landside slope and toe.

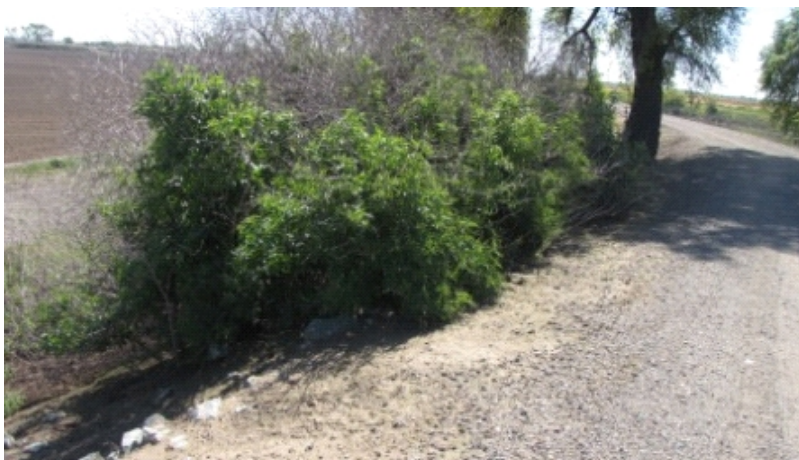
Looking northwest at elderberries on landside slope and toe.

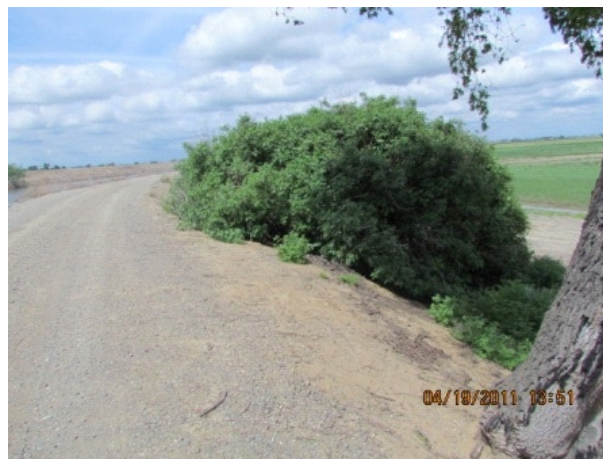
Levee Mile Report Line	4
Start Levee Mile	0.41
End Levee Mile	0.41
Location	Land Side
Category	Earthen Levee
Item	Vegetation

Looking south at elderberries on landside slope.

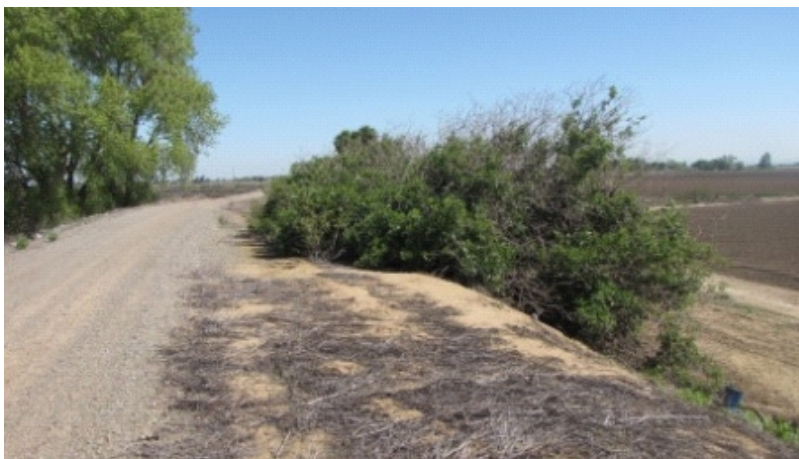
Levee Mile Report Line	8
Start Levee Mile	0.74
End Levee Mile	0.74
Location	Land Side
Category	Earthen Levee
Item	Vegetation

Looking south at elderberries on landside slope and toe.

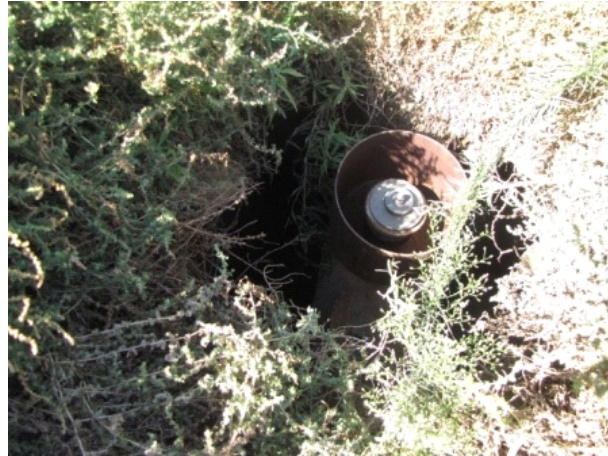
Looking at top of siphon on waterside shoulder with 3' of caving around pipe.

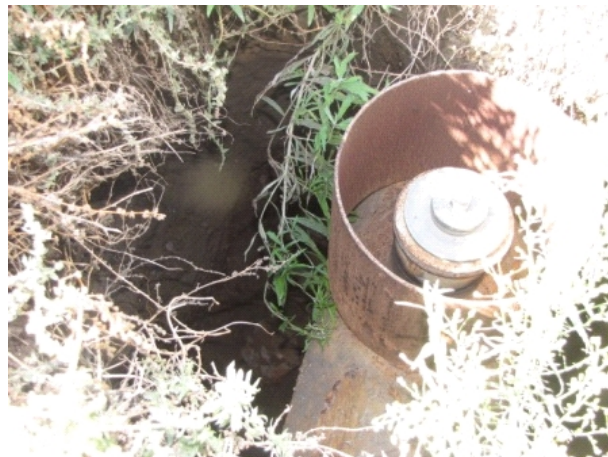
Levee Mile Report Line	9
Start Levee Mile	0.79
End Levee Mile	0.79
Location	Water Side
Category	Interior Drainage & Piping Systems
Item	Erosion Areas

Looking at caving around 10" siphon pipe on waterside shoulder.

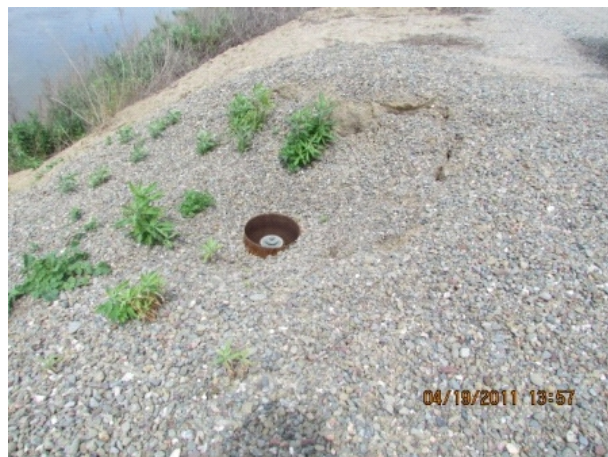
Levee Mile Report Line	9
Start Levee Mile	0.79
End Levee Mile	0.79
Location	Water Side
Category	Interior Drainage & Piping Systems
Item	Erosion Areas

Looking south at depression greater than 6" on waterside shoulder.

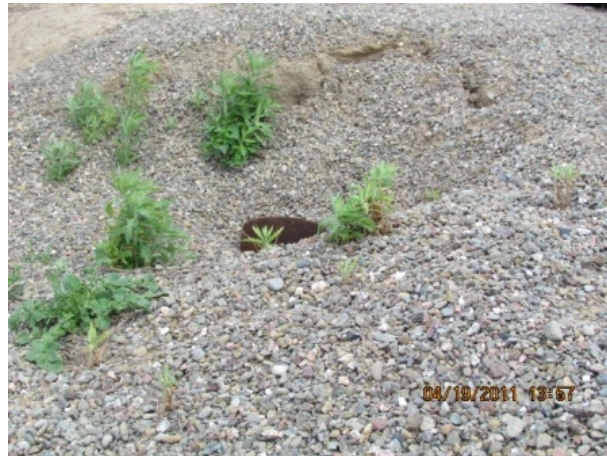
Looking south at depression greater than 6" around siphon on waterside shoulder.

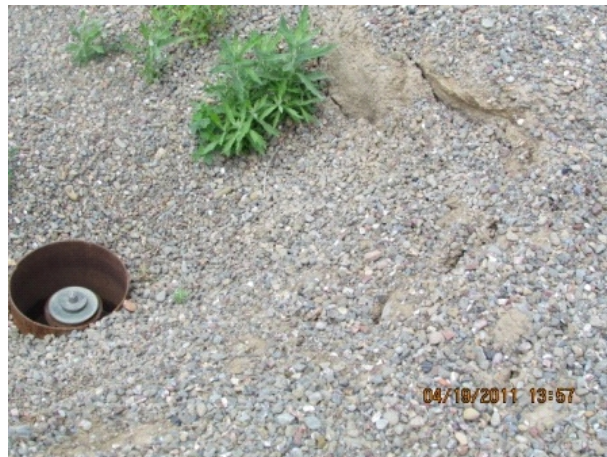
Levee Mile Report Line	9
Start Levee Mile	0.79
End Levee Mile	0.79
Location	Water Side
Category	Interior Drainage & Piping Systems
Item	Erosion Areas

Looking at top of siphon with a depression greater than 6" on waterside shoulder.

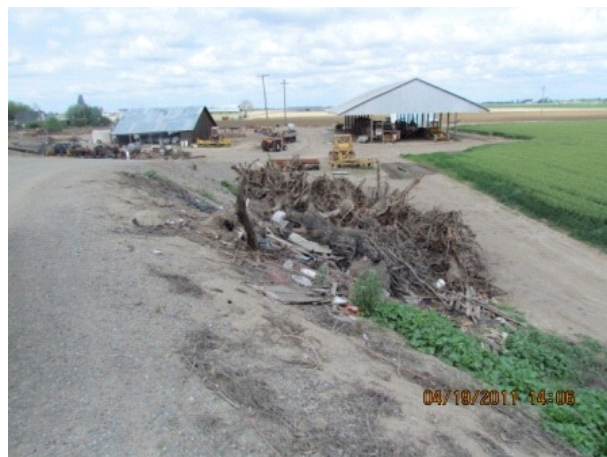
Levee Mile Report Line	11
Start Levee Mile	1.14
End Levee Mile	1.14
Location	Land Side
Category	Earthen Levee
Item	Encroachments

Looking southwest at pruning pile on landside slope.

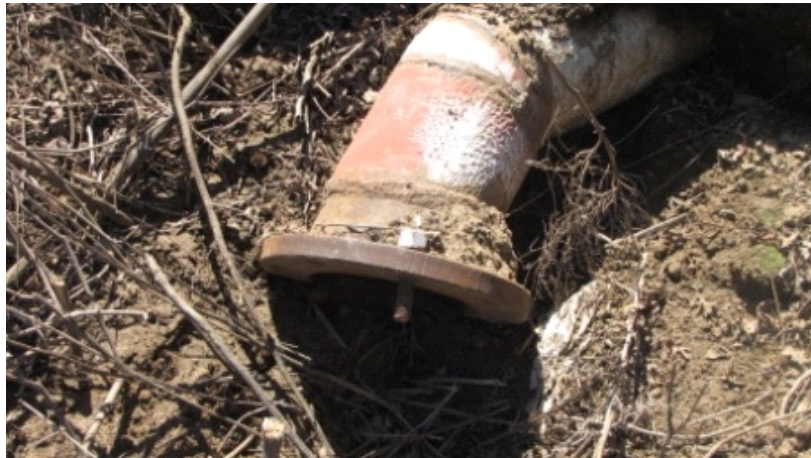
Looking east at pipe on landside slope.

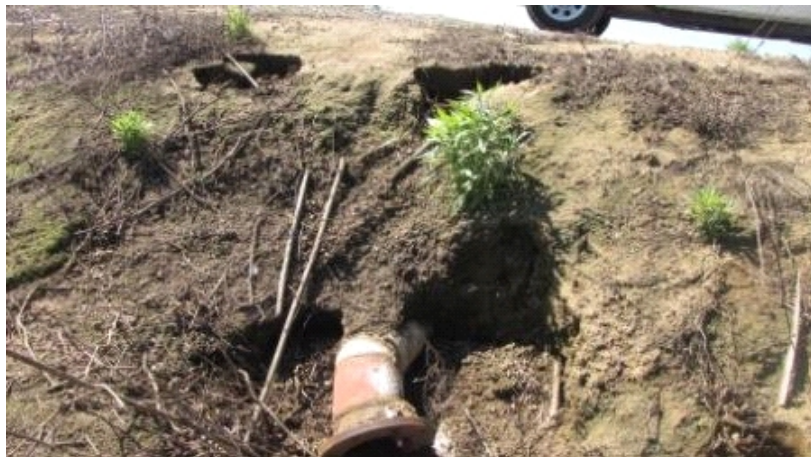
Levee Mile Report Line	16
Start Levee Mile	1.40
End Levee Mile	1.40
Location	Land Side
Category	Earthen Levee
Item	Encroachments

Looking east at pipe and erosion just above pipe on landside slope and shoulder.

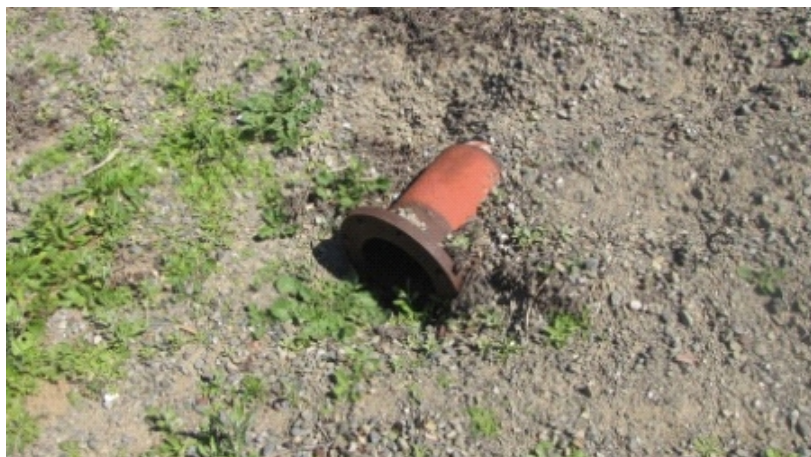
Levee Mile Report Line	16
Start Levee Mile	1.40
End Levee Mile	1.40
Location	Land Side
Category	Earthen Levee
Item	Encroachments

Looking west at east end of pipe on waterside slope.

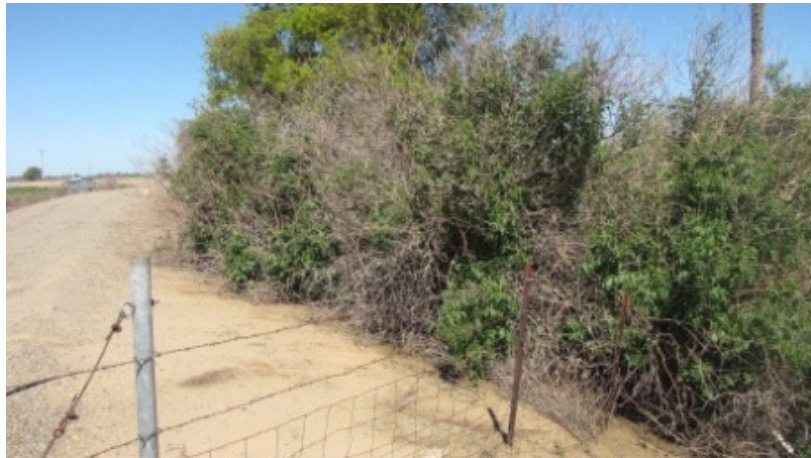
Looking south at elderberries on landside slope and toe.

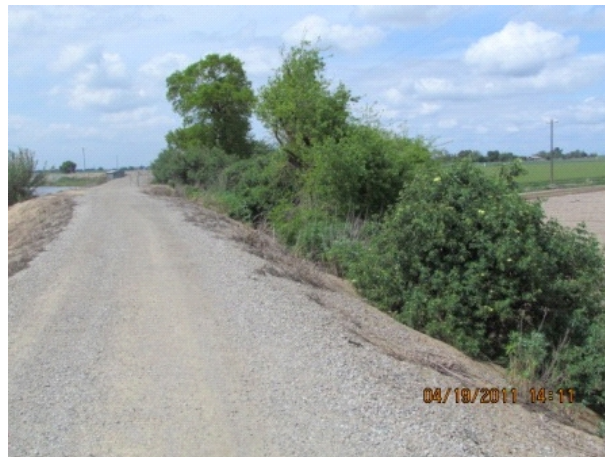
Levee Mile Report Line	17
Start Levee Mile	1.41
End Levee Mile	1.41
Location	Land Side
Category	Earthen Levee
Item	Vegetation

Looking southwest at elderberries on landside slope.

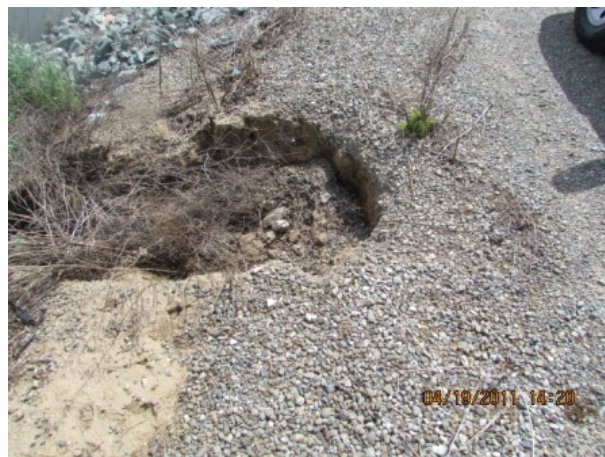
Levee Mile Report Line	20
Start Levee Mile	1.89
End Levee Mile	1.89
Location	Water Side
Category	Earthen Levee
Item	Slope Stability

Looking southeast at depression greater than 6" and slope stability on waterside shoulder and slope.

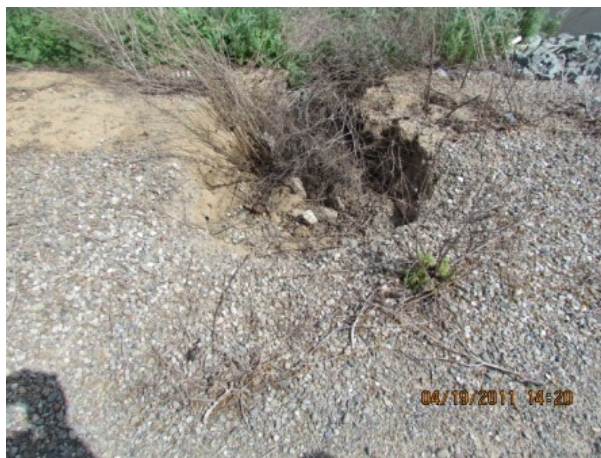
Looking east at depression and slope stability on waterside slope.

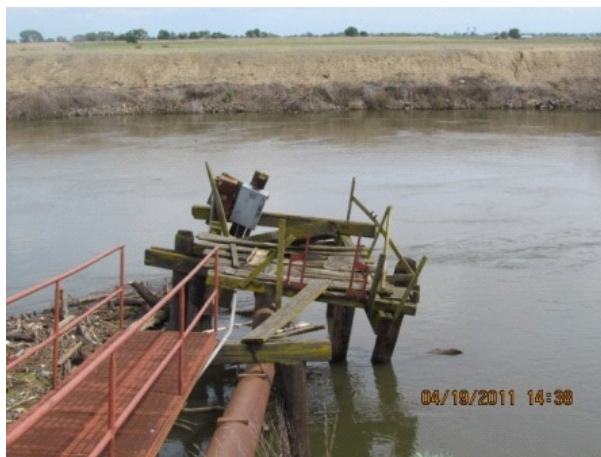
Levee Mile Report Line	29
Start Levee Mile	2.64
End Levee Mile	2.64
Location	Water Side
Category	Channels
Item	Encroachments

Looking east at dilapidated pump platform

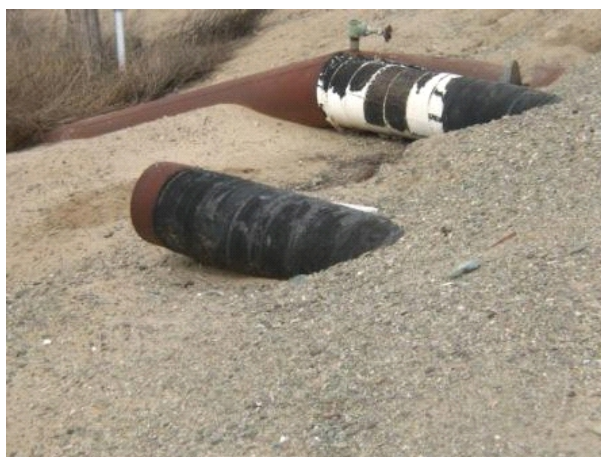
Levee Mile Report Line	30
Start Levee Mile	2.65
End Levee Mile	2.65
Location	Crown
Category	Earthen Levee
Item	Encroachments

Abandoned pipe at LM 2.65 landside view

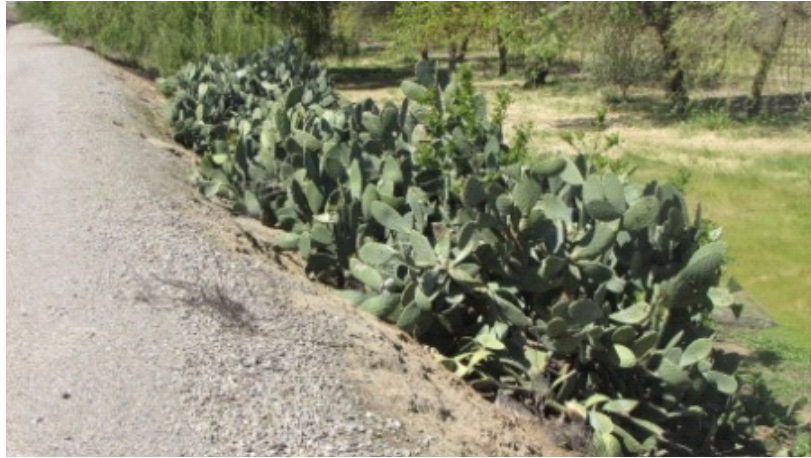
Looking southwest at overgrown cactus on landside slope.
